C-0305	Shipyard: Dakota Creek Industries	
Prepared by:	Date:	Program Officer:	
Paul D. Bueren	23 December, 2013	Robert (Tim) Schnoor	
Scripps Institution of		Office of Naval Research	
Oceanography (SIO)		875 Randolph St	
297 Rosecrans St.		ONR 321	
San Diego, CA 98106		Arlington, VA 22203-1995	
Distribution Statement A: App	Report No. A002.047

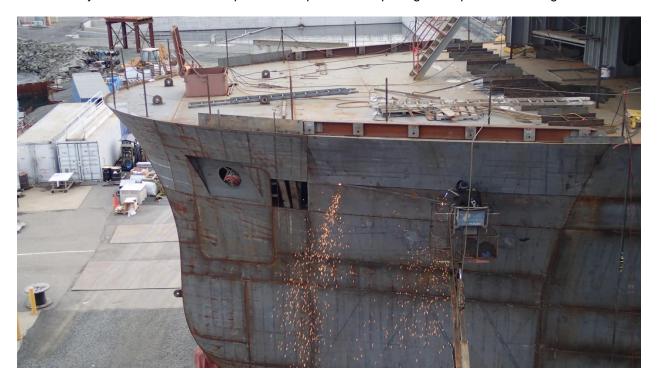
Sally Ride 02 Deck – The final, aft section of the 02 deck has been landed onto the 01 Deck House.
